CFMEU SAFETY ALERT

PLASTERBOARD CARTS

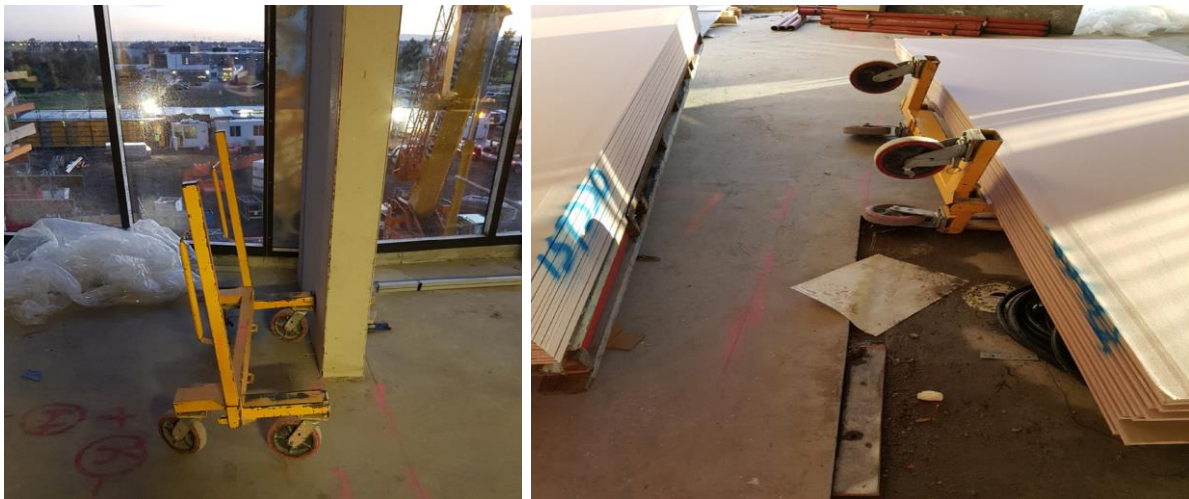
A worker has been hospitalised after a load, apparently under capacity for the plant, tipped and crushed him. The plant, a Telpro Panellift Plasterboard Cart manufactured by Intext, should not be used until further notice.

The Telpro Panel lift Plasterboard Cart is an unsafe piece of plant due to instability once they are loaded up.

The tag on the plant says it is good for between 1.3-1.8 tonne, but this is for downward load. Once the plant with load is moved, it becomes very unstable.

There is no documentation on safe use of this plant from the manufacturer.
